August 25, 2020

I was asked by Mr. Josh Rennaker, a landscape architect with Baer Design Group to assess multiple trees at a proposed development (Application #DSRFY2020-14) on the northwest corner of West Adams Street and N 43rd Avenue for health and relative safety. This letter is required by Title 8, section 8-4I-7 (Tree Preservation Provisions) of Garden City Municipal Code.

Attachment A – List of Assessed Trees

Attachment B – Photographs

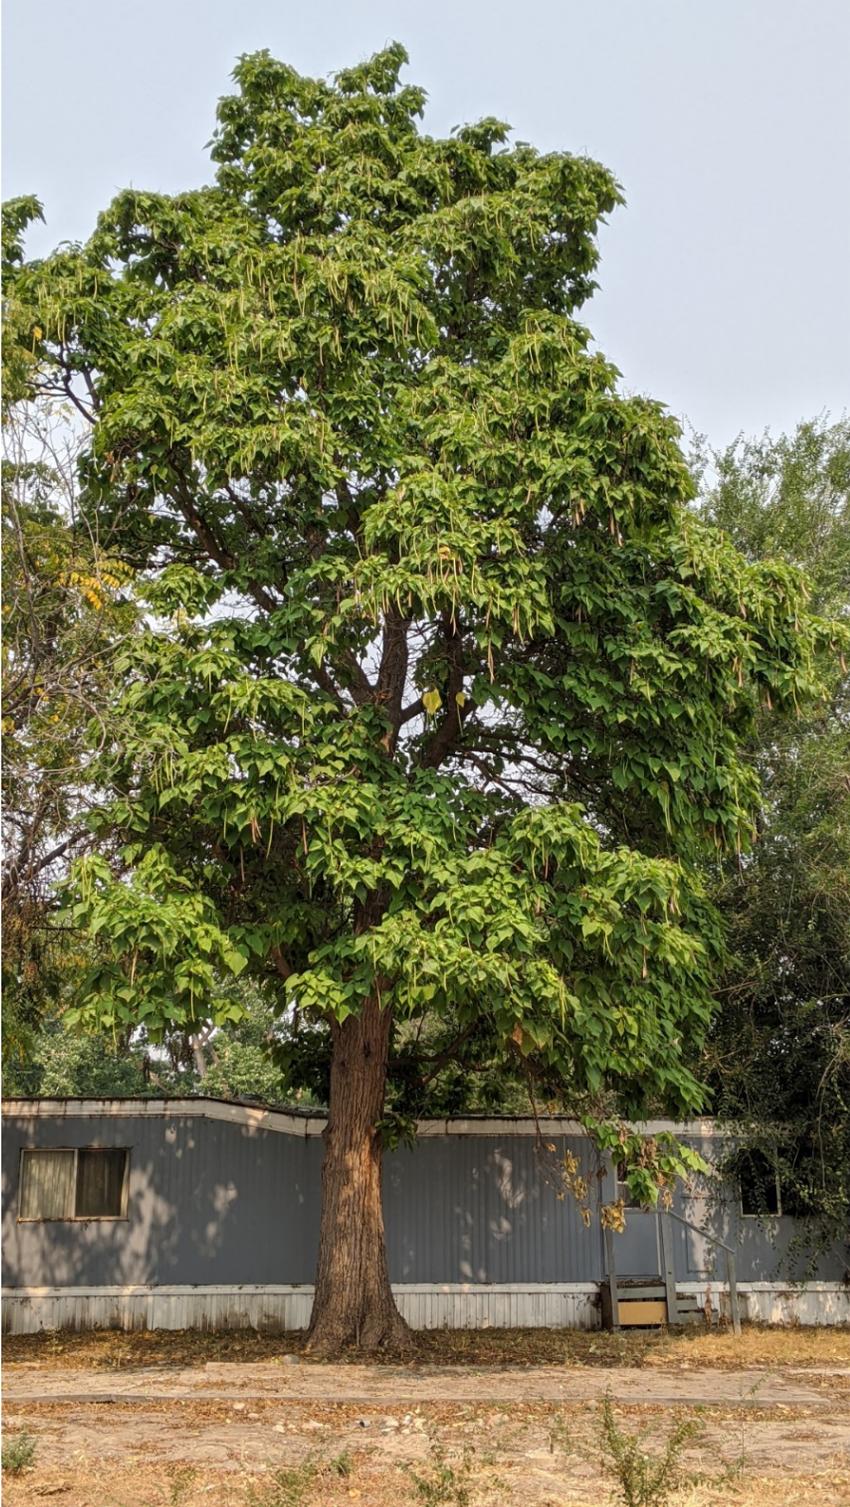
Species	Trunk Diameter	Condition	Notes
Catalpa	31	good	Good health/structure
Catalpa	18	fair	Low scaffold branch
Ponderosa Pine	23	fair	
Scotch Pine	22	fair	Low scaffold branch
Total diameter	94

Figure 1 - 31" Catalpa

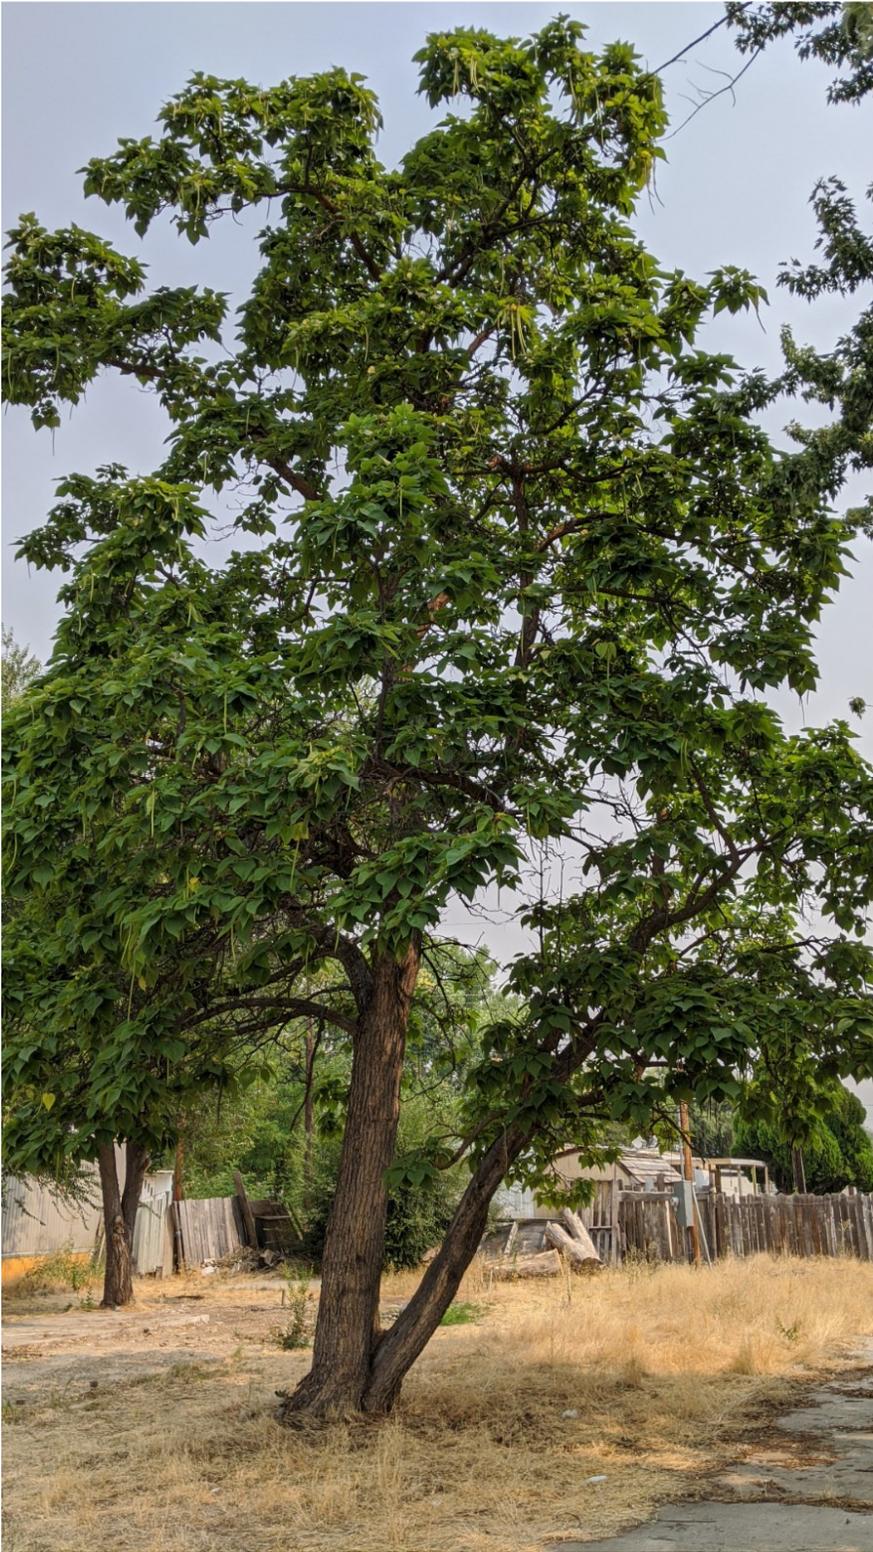
Figure 2 - 18" Catalpa

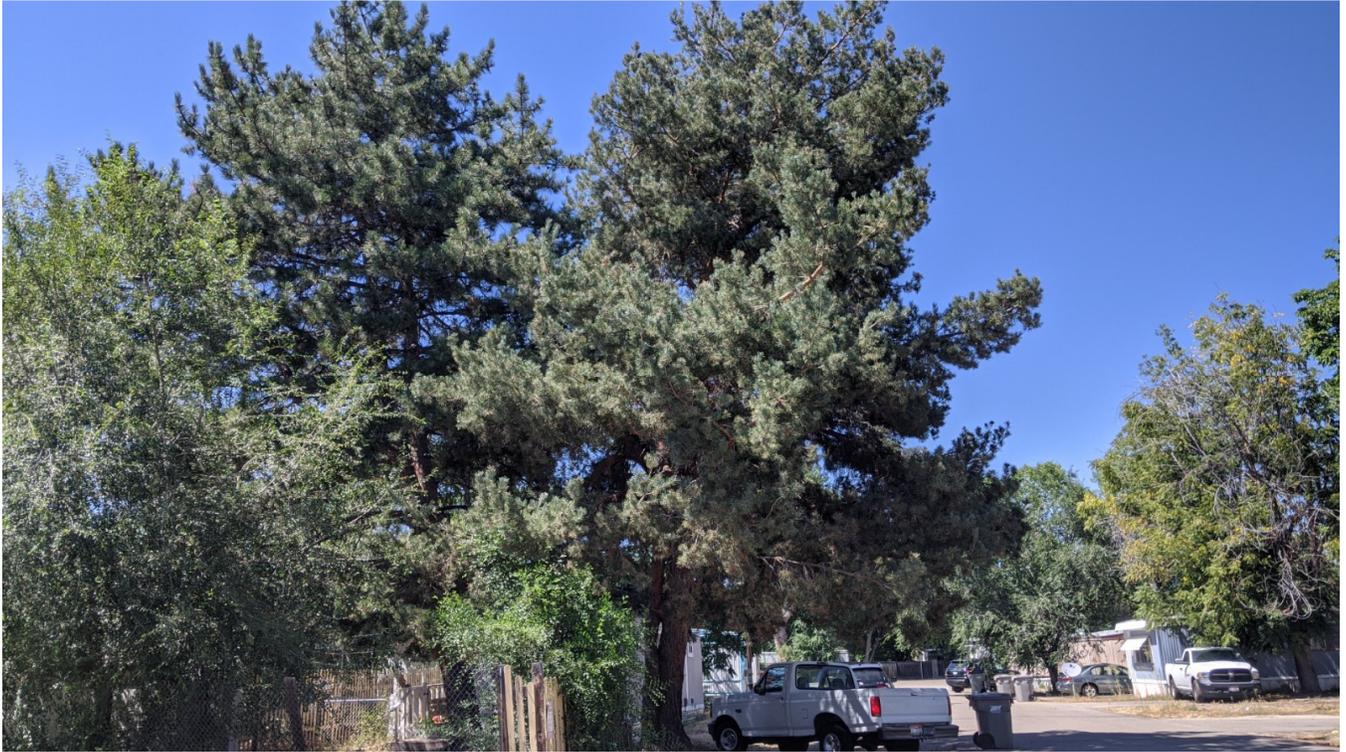
Figure 3 - 23" Ponderosa Pine (left) and 22" Scotch Pine (right)
