# Tree Assessment and Protection

## for Jake and Val Heusinkveld

### At 3675 Gramarcy Lane

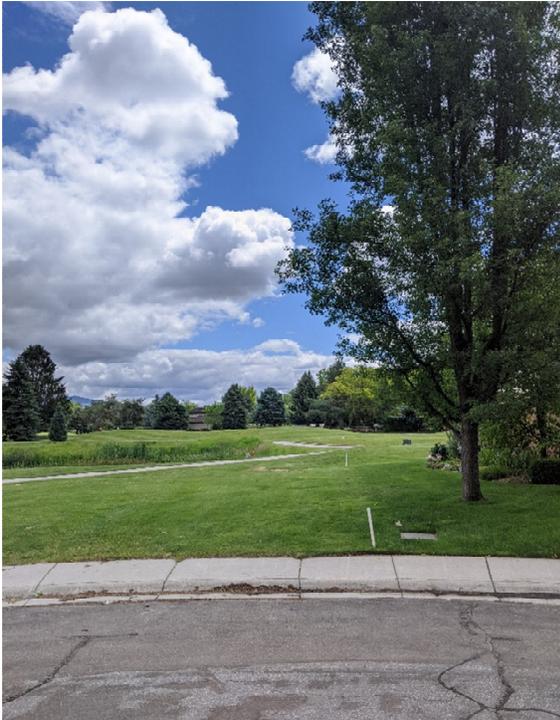
*Figure 2 - Flowering Pear on north side of home.*

On the north side of the home, a 13-inch diameter flowering pear is growing. The tree is in good health, having no obvious dieback in the canopy and no outward sign or symptom of insect or disease infestation. There are notable bark inclusions on a couple of larger branches, but these are fairly common for this variety of Flowering Pear, which is likely 'Chanticleer' or possibly 'Capitol'. Both are varieties selected for upright or columnar growth. At left is a photograph of the Heusinkvelds pear tree. To the north of this tree, a new pathway easement is proposed, with a 10-foot planter adjacent to the property line.

Concerns around the health of the flowering pear tree center around the construction of the proposed pathway and planters. The 10-foot planter should be placed and constructed with recognition of the presence of tree roots from this tree.

**Update:** The plantings adjacent to the flowering pear should not cause significant harm to the root system of this tree (is excavation/tilling or addition of soil is very limited). However, limiting of planting near the canopy of red maple (1) is still advised.

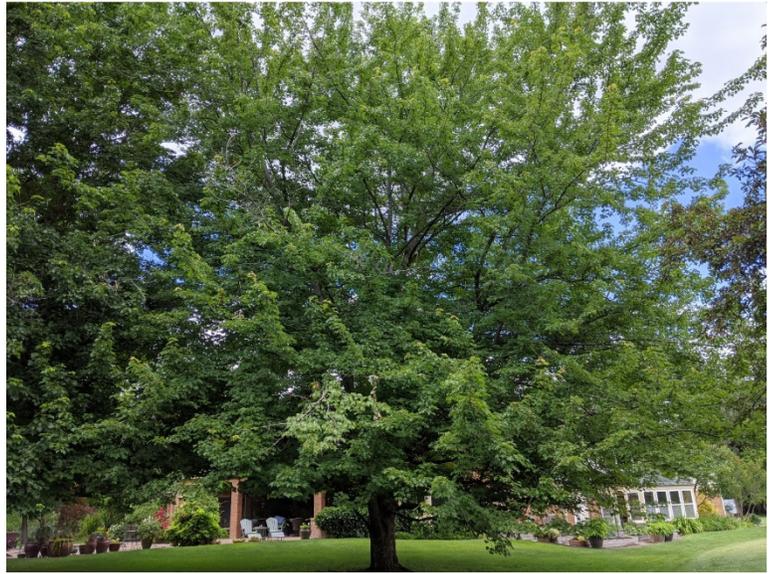
The northernmost tree is a 25-inch diameter tree in good health. There is minor branch dieback, mostly interior to the canopy. I saw no dead branches in excess of 2 inches in diameter. There are no obvious signs of insect or disease infestation at present. The structure of the tree appears to be sound, with no outward indication of interior decay. No recent pruning cuts are present on the tree, nevertheless, the branch structure and attachments appear to be quite good, in my opinion. The canopy of this tree extends approximately 30 feet from the trunk to the shared property line with the proposed development. Several smaller branches are growing quite low from the trunk and lower scaffold (main) branches. Figure 3 shows this maple, looking from the east, toward the house.

Figure 3 – 25-inch diameter red maple

Eliminate proposed planting of trees or tall shrubs adjacent to the flowering pear tree and red maple (1). The presence of the existing trees and the Heusinkveld's vegetable gardens should take precedence over any new plantings.

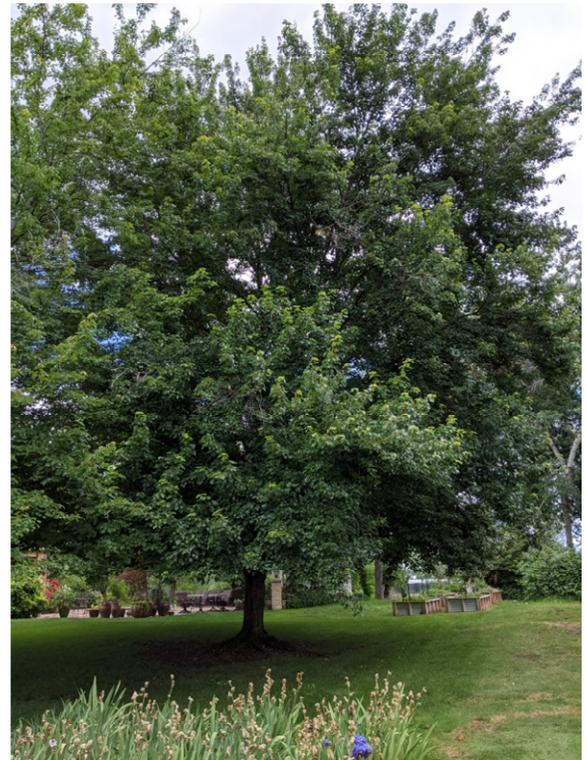
About 35 feet south of the trunk of the maple described above is another red maple. Though it measures 22 inches in diameter, this tree is almost identical in other aspects to the first. There is only minor branch dieback, with no outward indication of insect, disease or decay presence. Here again, branch structure appears quite sound. The reach of the canopy extends approximately 25 feet toward the property line shared with the proposed development, and smaller branches are growing low, as on the first tree. This tree is pictured at right.

Figure 4 - 22-inch Red Maple

To best preserve the canopy and root structure of the two red maple trees, I strongly recommend a setback of at least 15 feet from the shared property line. This should reduce required crown pruning and root damage/removal.

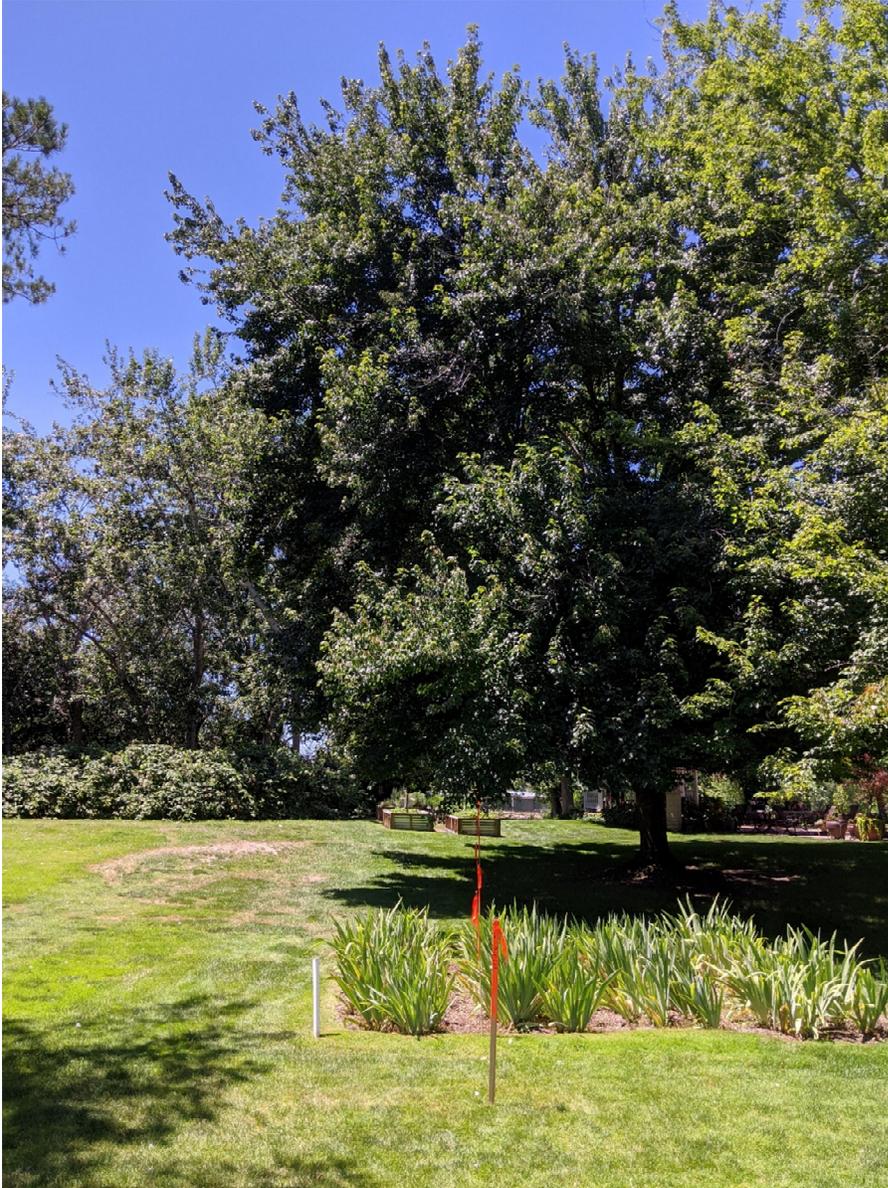
**Update:** Property lines stakes and proximity to tree are pictured below. The location of the property line comes is approximately 10 – 12 feet from major scaffold roots and the trunk of red maple (2). With a 5-foot setback, significant loss of roots is likely, particularly where a building is proposed. In addition, significant crown pruning will be needed to allow equipment to operate and to create room for a 2-level residence. With the property line at this location, Recommendation #2 continues to be strongly emphasized as is.
