# Tree Assessment and Protection

## for Jake and Val Heusinkveld

### At 3675 Gramarcy Lane

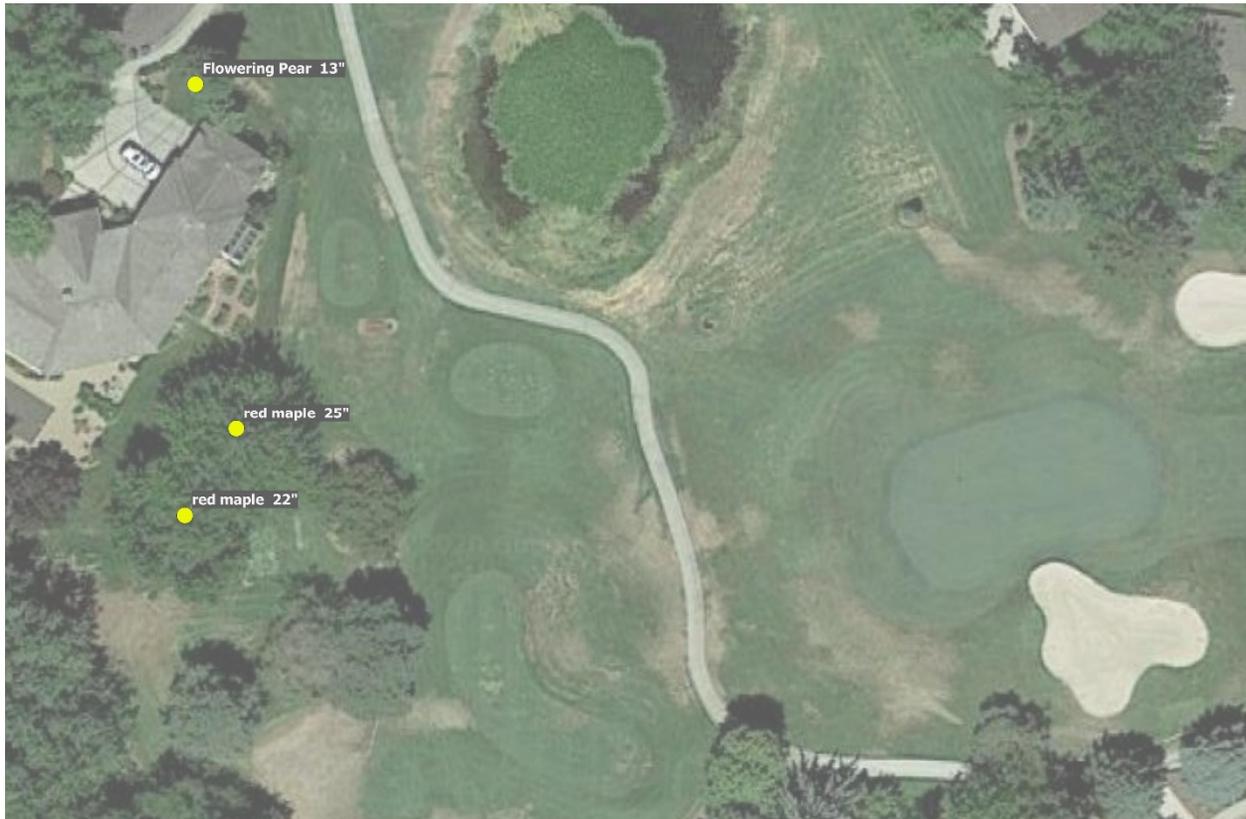
Figure 1 - Heusinkveld Trees and area of proposed development

On May 28<sup>th</sup>, I met with Jake and Val Heusinkveld at their home at 3675 Gramarcy Lane in Boise. They had contacted me the week before as they were concerned about a new development next to their property. Three new homes are proposed in the open space southeast of their home. Of particular concern is the impact this development may have on three trees owned by the Heusinkvelds. Below is an aerial image of their residence with the three trees identified.
