Glass Island View Subdivision Application SUBFY2020-6

On behalf of the applicant, Glass Creek, LLC, I am submitting information related to the Glass Island View Subdivision Preliminary Plat Application SUBFY2020-6. The subdivision is proposed to include three custom infill residential lots and one common lot on the Plantation Country Club property owned by Glass Creek adjacent to the Boise River.

Subject: Incorporating accuracy statistics when attempting to quantify cut & fill volumes based on LiDAR data.

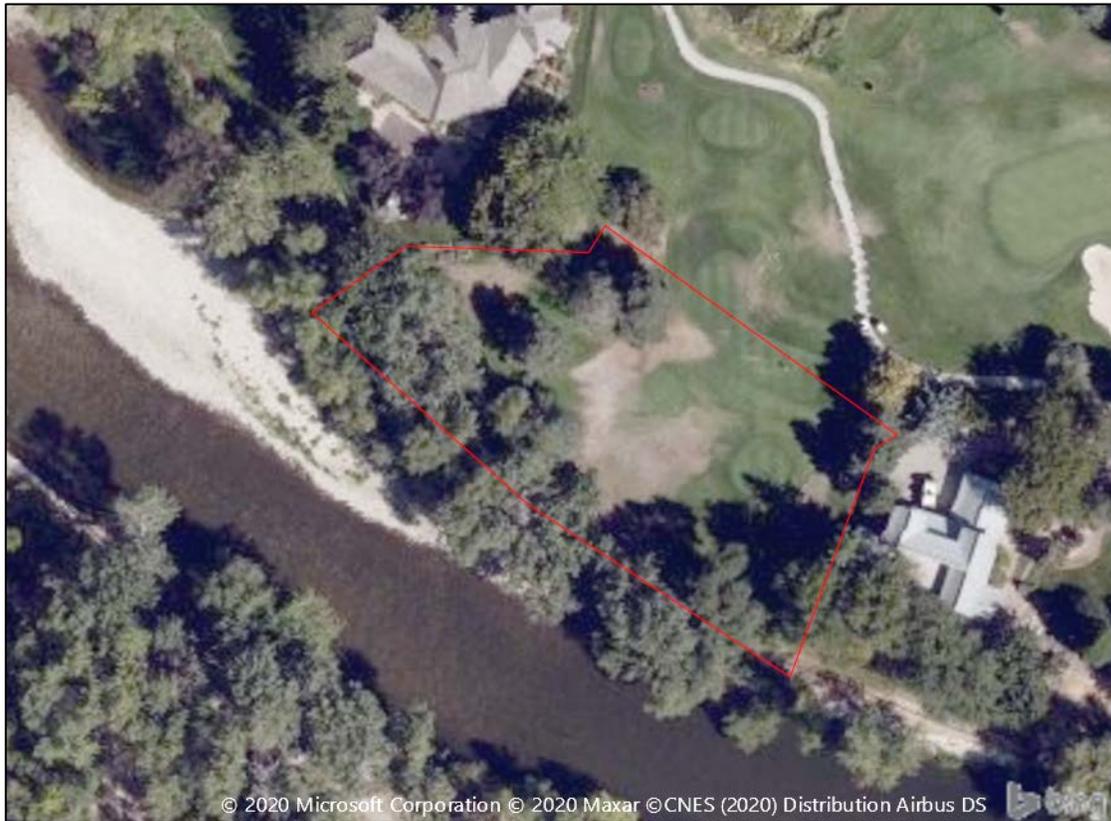
The vertical accuracy of the data sets must be taken into account when attempting to quantify fill. When we incorporate the RMSE of each data set into the comparison we create a range of volumes. We tried to match Quadrant’s area of comparison (figure below). Note that not all of the area is vegetated but a more precise analysis was not possible at the time. We can say the volume change over time lies somewhere between 1,100 cubic yards of cut and 2,550 cubic yards of net fill between 2007 and 2019.

Net Change (cu.yds)
Upper Limit Estimate	2,550 (Fill)
Unadjusted Estimate	790 (Fill)
Lower Limit Estimate	1,100 (Cut)

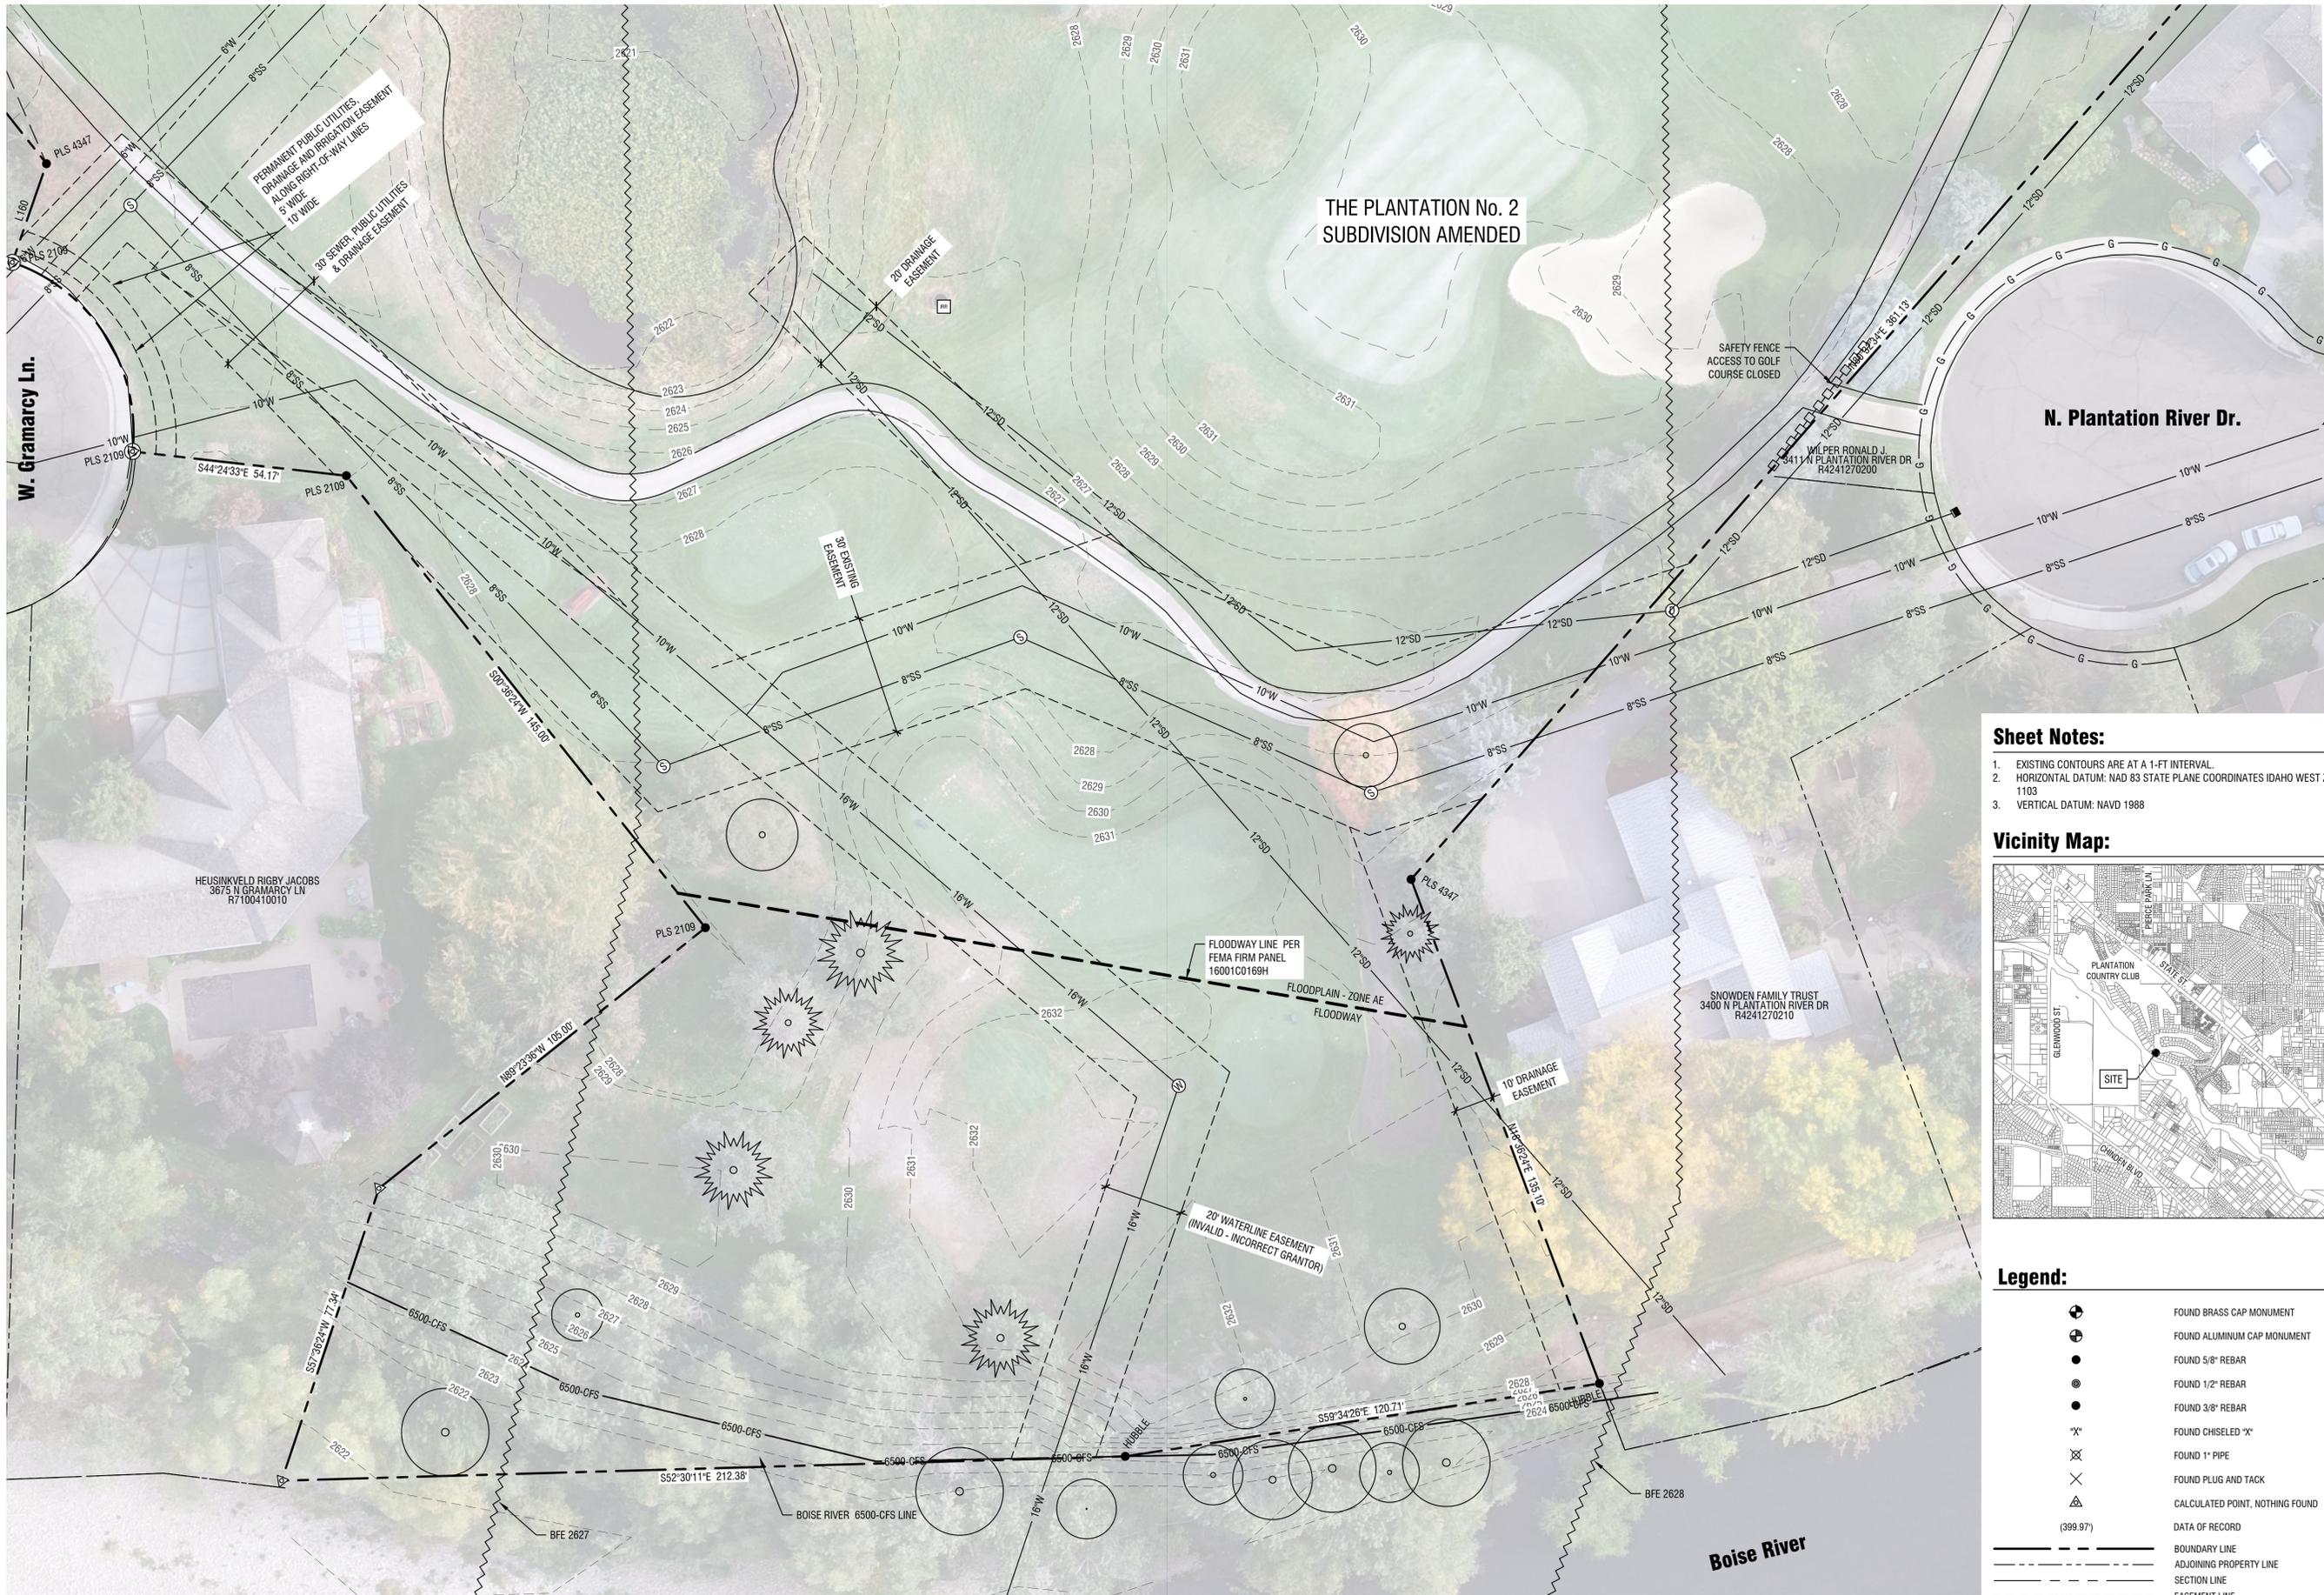
**Existing Conditions -
Topographic Survey -
Project Area**

- EXISTING CONTOURS ARE AT A 1-FT INTERVAL.
- HORIZONTAL DATUM: NAD 83 STATE PLANE COORDINATES IDAHO WEST ZONE 1103
- VERTICAL DATUM: NAVD 1988
